Assessing the Rockburn Branch Subwatershed of the Lower Patapsco River for Restoration Opportunities

Prepared for:
Howard County, Maryland
Department of Public Works
Bureau of Environmental Services
NPDES Watershed Management Program

Prepared by:
JoAnna Lessard and Sam Stribling, Tt

January 23, 2006
Final Draft

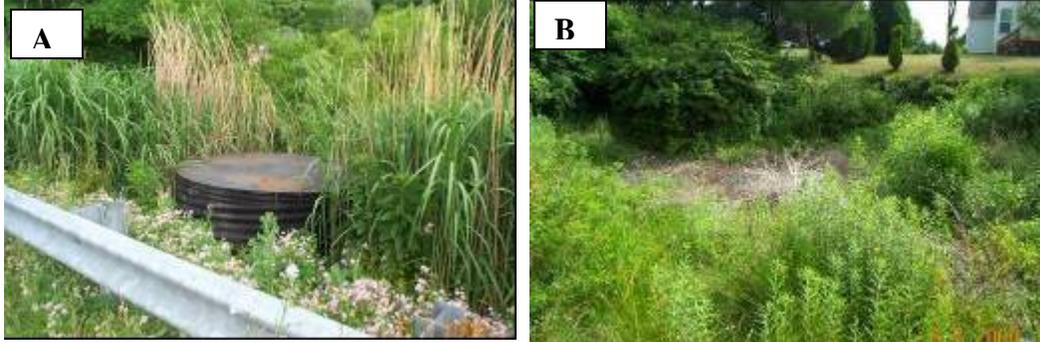
Description: Currently this residential area off Kerger Rd. is bordered by a stormwater wetland and an adjacent dry pond. These two areas do not appear to be hydrologically connected currently.

A) Barrel in front of pond and B) Dry pond next to stormwater wetland

***Recommendation:** This priority project is an opportunity to retrofit the dry pond and incorporate this area into the existing stormwater wetland facility. Invasive vegetation removal and native plantings along with outreach should be included. This type of program may be well received by the public as there was concern expressed by some residents over trash being dumped in the area of the dry pond and that something would happen to the wetland, while field workers were observing these facilities.

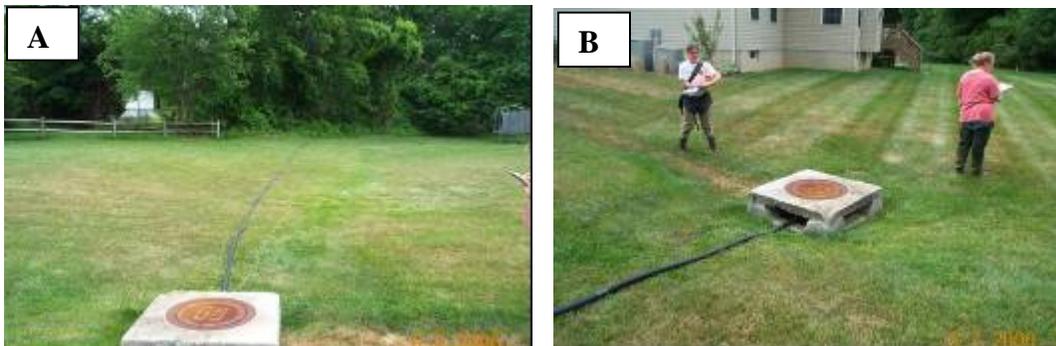
Description: Storm drain inlet near residential area has a small pipe discharging to the inlet that appears to be connected to a pump.

A) Stormdrain front view B) Stormdrain side view

Recommendation: Address stormdrain connection and retrofit stormdrain into a bioretention facility capable of providing water quality treatment. Maintain the existing structure for overflow control. This project would require coordination between the county and property owners.

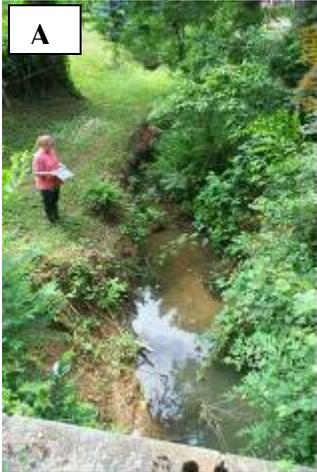
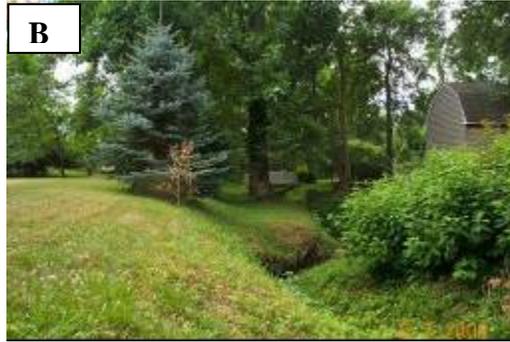
Description: The stream bank is eroding due to lack of riparian vegetation to slow runoff and hold soils together.

A) Top view of bank B) Side view of bank

Recommendation: An outreach/education program should be done to try to maintain a no-mow margin along both banks. There is also potential to replant existing turf grass with native riparian vegetation.

Due to setback constraints bank grading, stream repair, and, revegetation are not possible along the entire restoration reach.

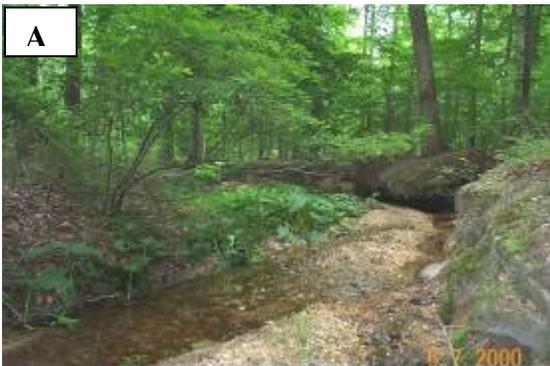
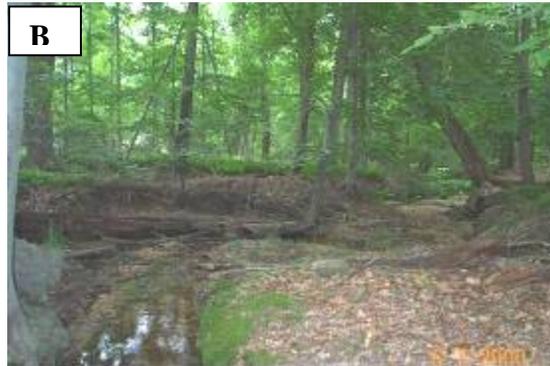
Description: Bank erosion problems were observed along this reach.

A) Fine sediment load and eroding banks along channel B) Another view of eroding banks along channel

Recommendation: Due to access limitations to the erosion site, pursuing upstream volume controls is recommended prior to initiation of stream repair efforts in this area.

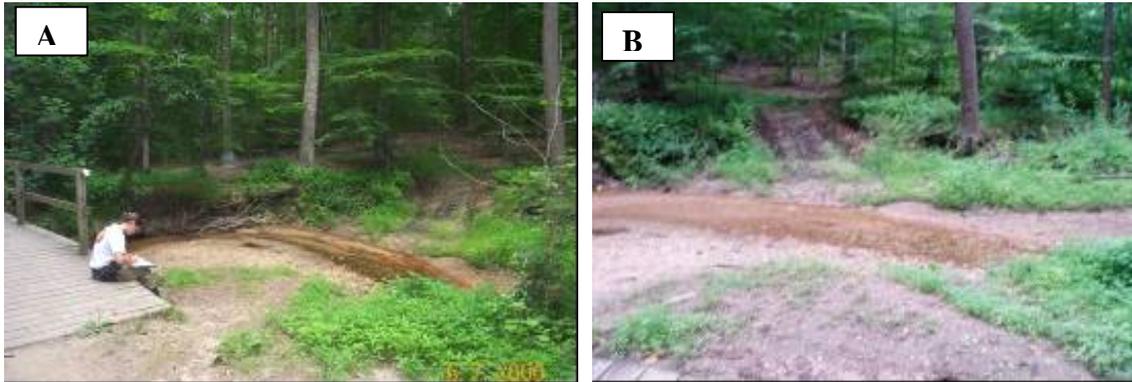
Description: A trail that crosses the stream, assumed to be used by trail users and mountain bikers, is causing erosion and sedimentation.

A) Bridge and trail crossing B) Close-up of trail crossing.

***Recommendation:** This priority project is a candidate for bank repair and revegetation. Trail signage and education/outreach that directs traffic to the adjacent bridge rather than through the stream and that incorporates local trail user groups is recommended. This outreach could be a fairly effective means of increasing awareness and interest in stream restoration by people who value the park.

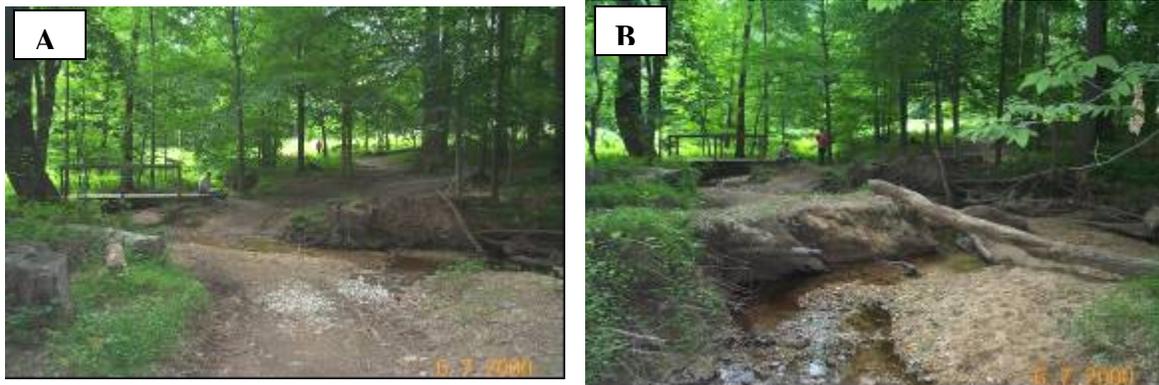
Description: Another stream crossing, assumed to be used by trail users and mountain bikers and is also creating sedimentation and erosion problems.

A) View of trail and erosion B) Eroding banks and sediment load

***Recommendation:** This priority project is also a candidate for bank repair and revegetation. Trail signage and education/outreach that directs traffic to the adjacent bridge rather than through the stream and that incorporates local trail user groups is recommended. This outreach could be a fairly effective means of increasing awareness and interest in stream restoration by people who value the park.

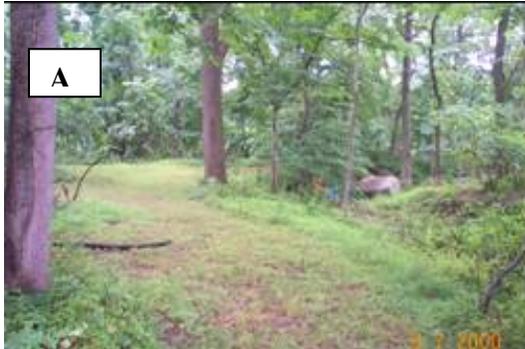
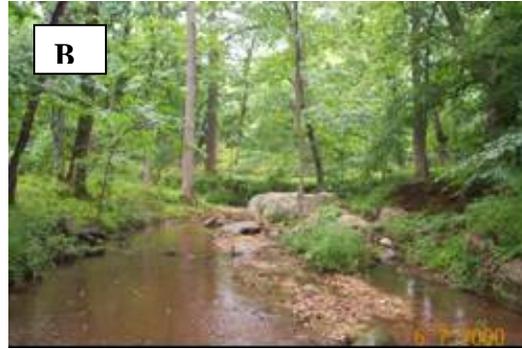
Description: Left bank riparian vegetation is limited at this site and there is some landscape debris in the buffer on the right bank.

A) View of turf grass on left bank B) View of stream, and landscaped areas around it

Recommendation: One bank is public land and other is private, therefore this project will require cooperation with the landowners to replace existing turf grass with native riparian species and remove landscape debris from banks.

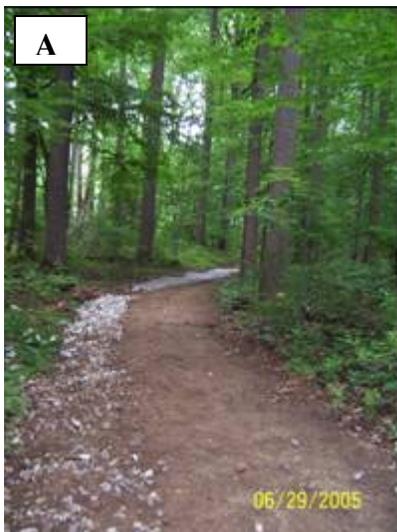
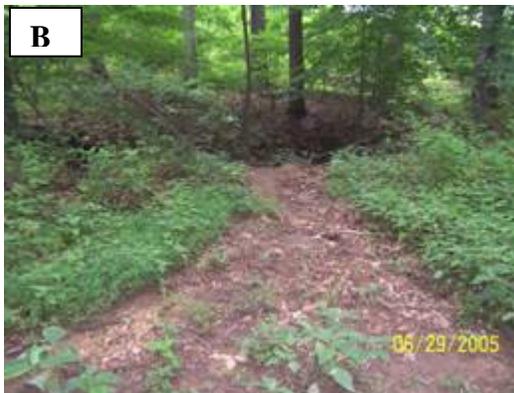
Description: Concentrated flow is eroding the trail and stream bank in this area.

A) View of trail. B) View of eroding trail leading to stream

***Recommendation:** Priority restoration activities include repairing the section of trail where the runoff is eroding it and the downstream channel bank as well. This small-scale project would be ideal for community volunteers and park users.

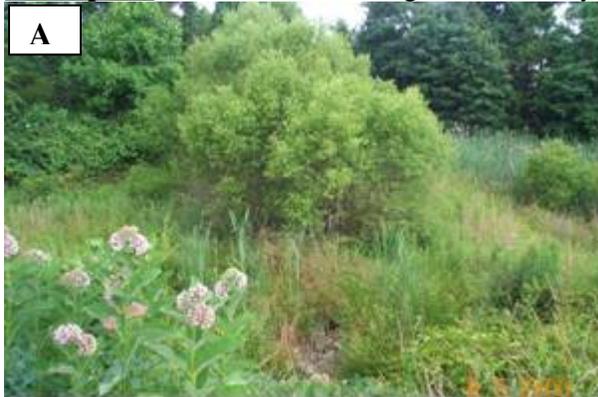
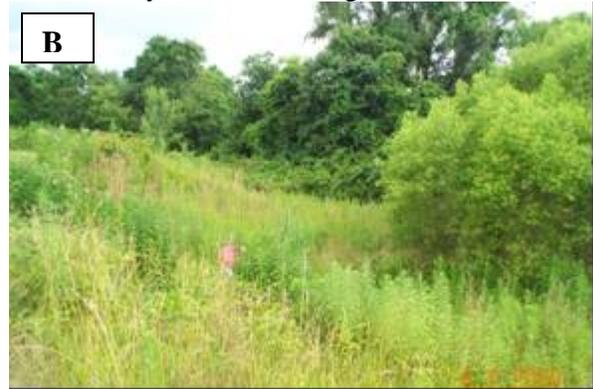
Description: Stormwater management facility dominated by non-native vegetation.

A) View of area with non-native species. B) View of area with more non-native species

Recommendation: Removal of non-native species and replanting with native riparian vegetation. This project is well suited for community volunteers or as an education/outreach effort.

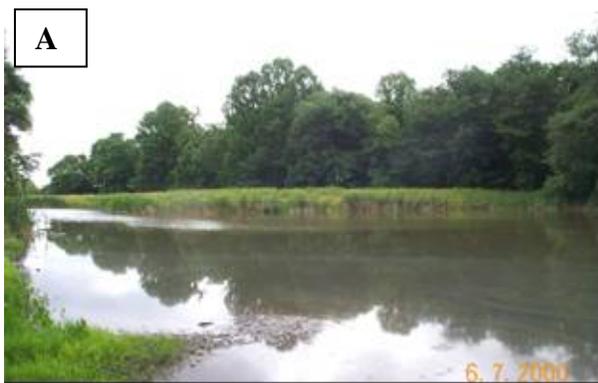
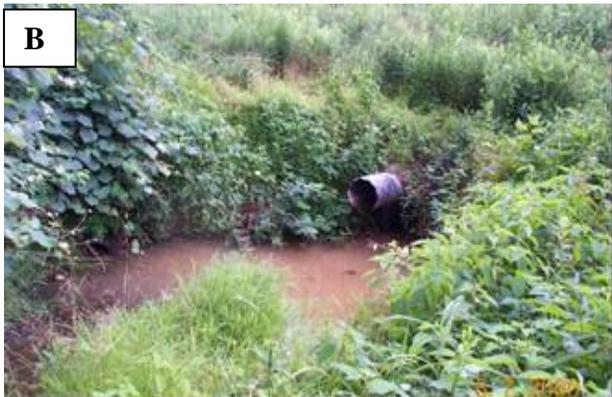
Dunteachin Pond Outfall Repair (Project - RB – 10)

Description: Existing corrugated metal pipe at this outfall shows signs of corrosion and leakage.

A) View of stormwater pond. B) View of corrugated metal pipe at outfall.

Recommendation: Repair the metal pipe at the stormwater pond outfall. Also could be a site for non-native vegetation removal and native plantings.

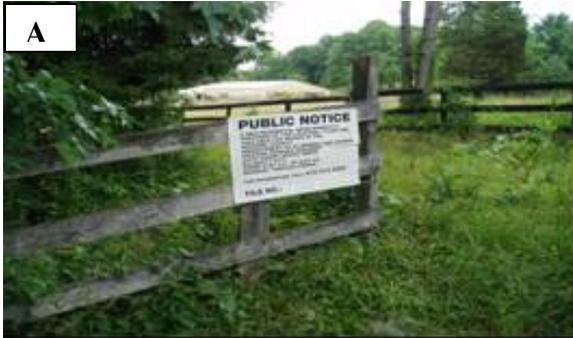
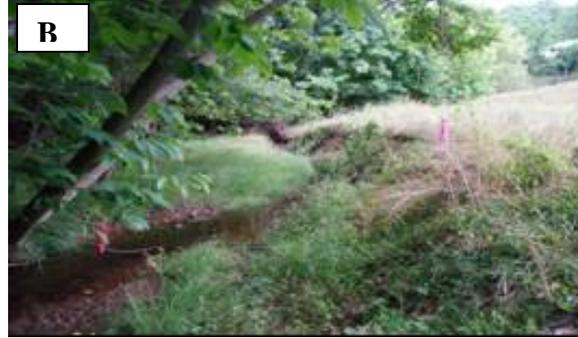
Description: A small tributary that flows north along an agricultural road off Elibank Drive is actively downcutting. The small tributary joins a larger tributary, which is also experiencing active erosion.

A) Public Notice of land to be developed. B) View of eroding bank and areas recommended to be reforested.

Recommendation: Stream repair and buffer planting opportunities exist on these tributaries. This area appears to be slated for development and may be able to include stream restoration/protection in the plans. At a minimum the floodplain/overbank areas should be protected and actively reforested. The larger tributary is not a good candidate for stream repair due to high, uncontrolled flows from upland areas. The smaller tributary has the potential for repair, however, as the drainage does not appear to extend south of I-95.

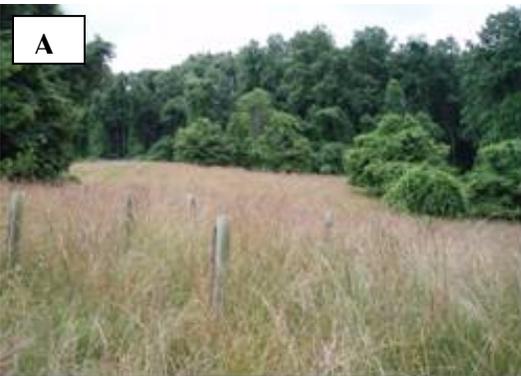
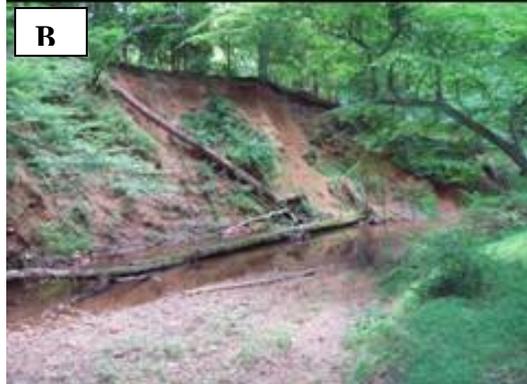
Description: Erosion of a tall bank is occurring at a bend in the river. It is unknown if this is a result of past channel modification activities or natural processes from upland run-off. There is evidence of recent buffer reforestation and upland reforestation in this area.

A) View of reforested areas. B) View of eroded tall bank.

Recommendation: Natural regeneration of the floodplain areas is feasible if left alone. One mowed area exists upstream of a pond and tributary. The purpose of this area is unknown. *No priority recommendations have been set for this project due to difficult access.*

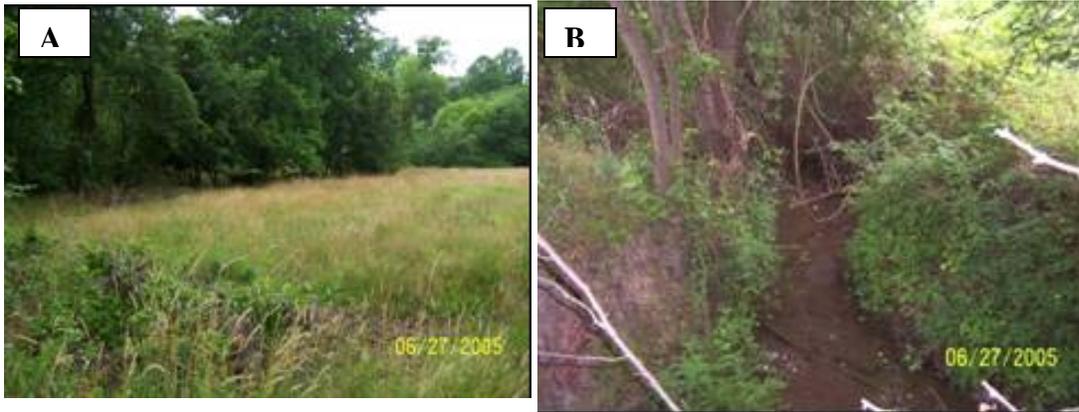
Description: This section of stream currently lacks an adequate buffer.

A) View of buffer on public land. B) View of stream with steep banks.

***Recommendation:** Although a minimal buffer (<10 ft) exists, active replanting of a broader and fully functional buffer on the publicly owned parkland is recommended for this priority project. There may be a utility corridor that would limit the available space, however.

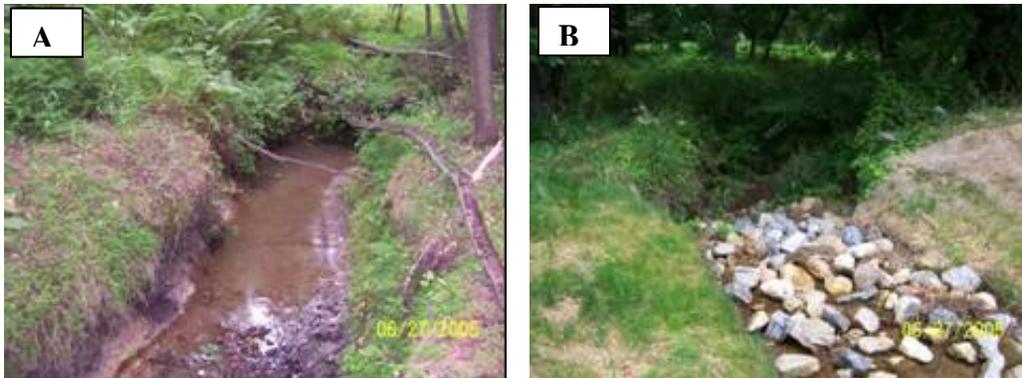
Description: Active downcutting is occurring in the reach downstream of the sewer crossing. This is likely due to upstream urbanization.

A) View of downcutting. B) View of sewer crossing.

Recommendation: On-site retrofits for the upstream neighborhoods are possible, however, road construction may pose a greater threat if this increases runoff to the stream. The sewer crossing also needs additional armoring to stop erosion from undermining and exposing the sewer.

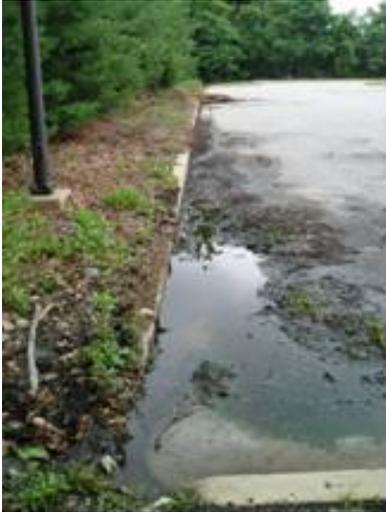
Description: This parking lot near the school entrance drains to two corner curb cuts. The downstream swales are lined with rip rap and meet below the parking lot. These swales join a drainage system collecting runoff from the middle school stormwater management facility. The drainage system is causing downstream erosion and scour.

View of curb on Elkridge Elementary School Parking lot.

***Recommendation:** Install rain garden/biofilters at two existing curb cuts to provide water quality treatment of parking lot runoff. Investigate the school drainage system and determine if redirection or diversion of runoff is possible at this priority site.

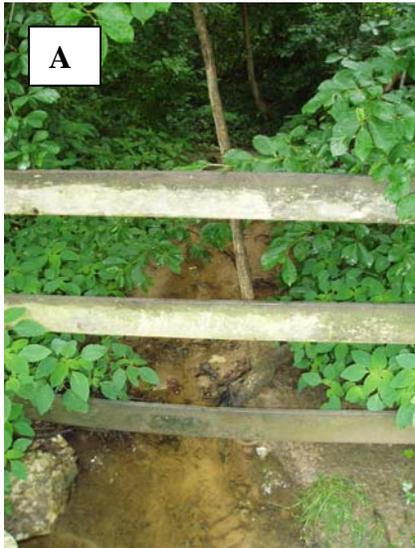
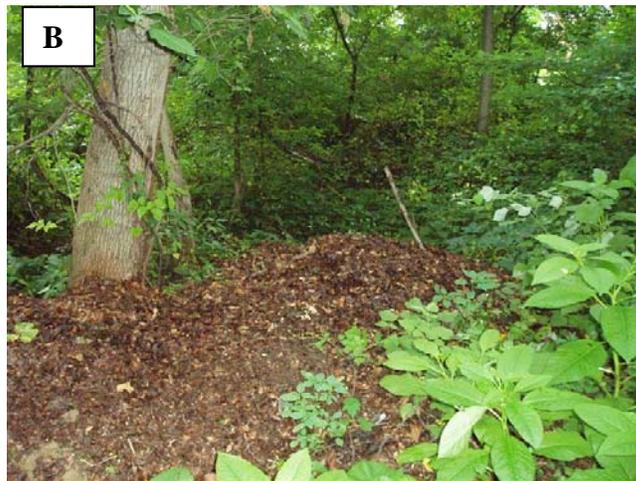
Description: Stream repair is needed on two channels originating from the Elkridge Elementary School, one from the stormwater management pond the other from the entrance parking lot. Yard waste was dumped into channels and erosion/unstable banks from upstream run-off is also a problem.

A) Stream channel. B) Yard waste dumped into stream.

***Recommendation:** Priority repair efforts should include removal of yard waste dumped into the channel, upstream stormwater volume controls (see Project RB-16 and 18), bank stabilization, and education/outreach activities.

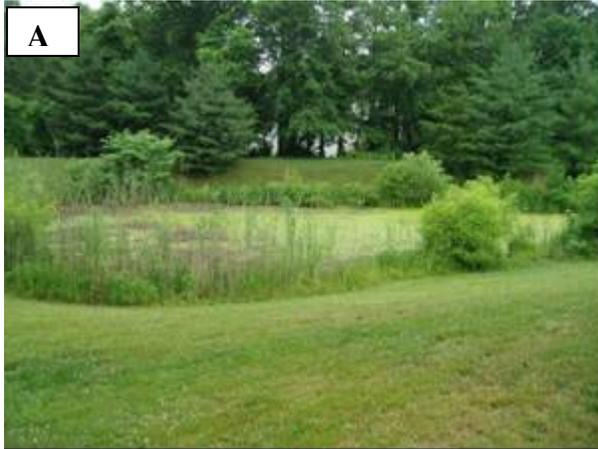
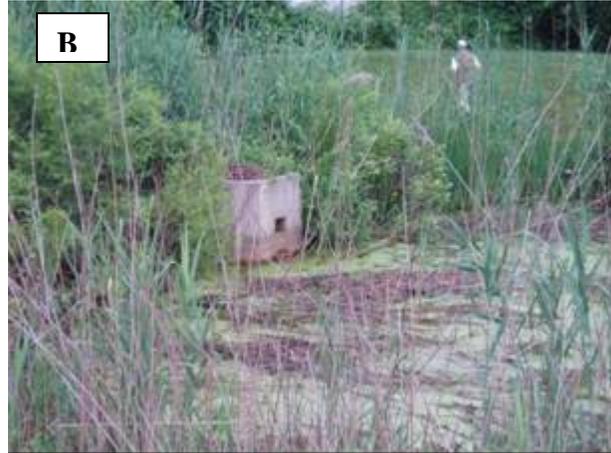
Description: A stormwater treatment facility near the school.

A) View of stormwater pond. B) View of riser structure.

***Recommendation:** This priority project involves retrofitting the existing stormwater pond to provide additional pre-treatment or increase capacity of the facility, by dredging or retrofit the overflow structure. This will improve treatment of first flush events and provide channel protection.

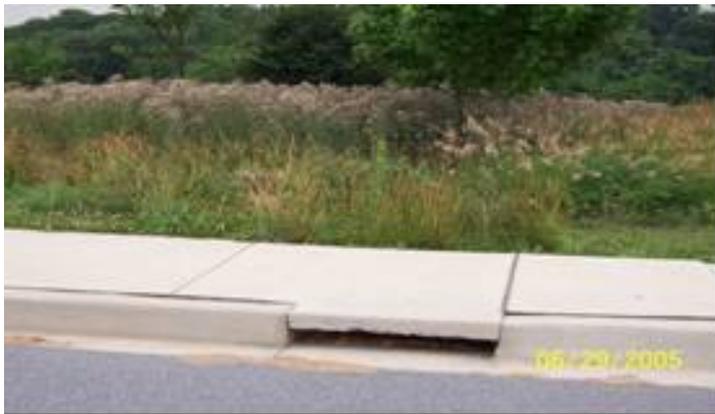
Description: The school has some stormwater treatment but could be used as a demonstration project to increase its effectiveness and local awareness at the same time.

View of parking lot runoff drain and grassy area.

***Recommendation:** Priority projects include incorporating bioretention areas into parking lot medians and turnabouts to provide water quality treatment for a dumpster storage area and parking lot runoff. Incorporating native BayScapes plantings as demonstration/educational projects at the entrance to the school property is also recommended.

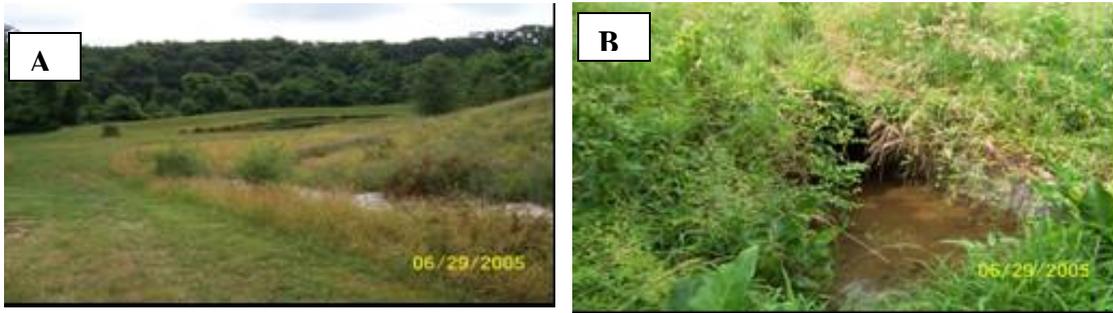
Description: The low flow orifice of the detention dry pond is clogged forming a permanent wet pool, but providing minimal volume protection to downstream channels.

A) Overview of extended detention dry pond. B) View of outfall.

***Recommendation:** Perform maintenance of extended detention dry pond.

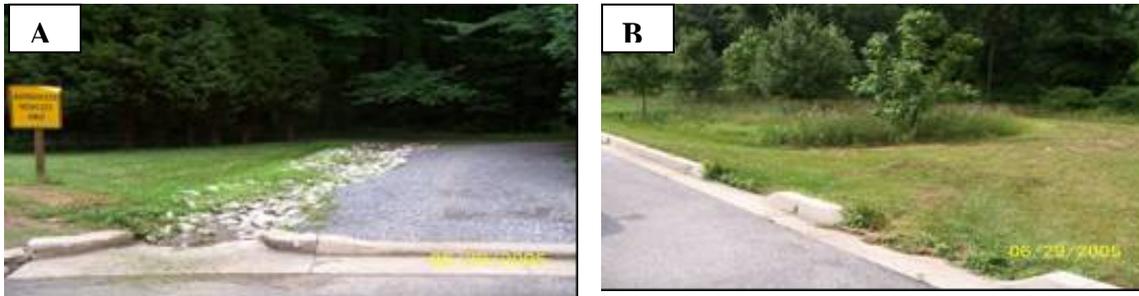
Description: Treatment of roadway and parking area drainage is not adequate and is causing erosion.

A) View of rip rap channel. B) View of roadway drainage area.

***Recommendation:** Improve roadway drainage by conducting stormwater runoff to drainage swales. Improve road and parking lot drainage by removing riprap in channel and creating a bioretention facility designed for channel protection and water quality volume.

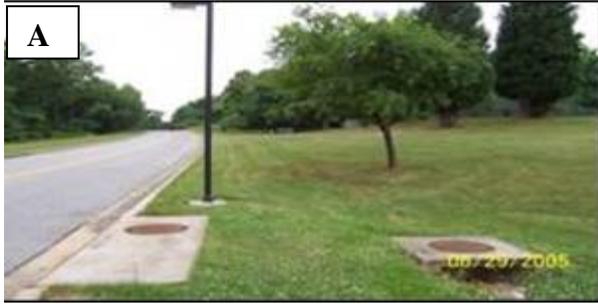
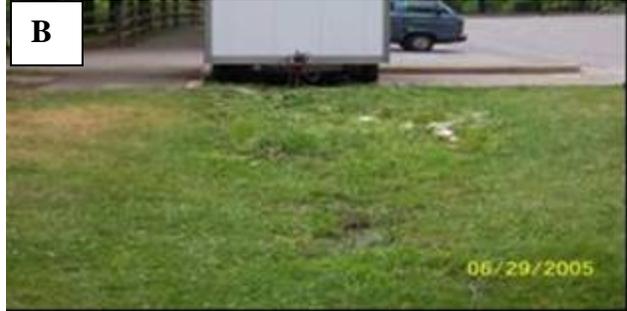
Description: Treatment of roadway and parking area drainage is not adequate.

A) View of entrance road. B) View of parking lot and potential retrofit area.

***Recommendation:** Provide treatment of roadway runoff by constructing a grassed swale parallel to the entrance road, reforest open areas where not specifically managed as open meadow, replace riprap with native plant material and add rain gardens at parking lot curb cuts. Also propose further study of parking lot use patterns to determine if porous paving alternative is feasible.

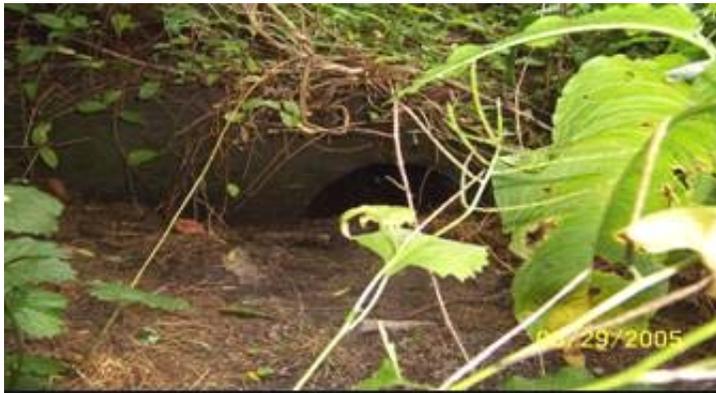
Description: The outfall culvert here is half filled with sediment.

View of culvert and sediment.

***Recommendation:** Priority project should be to perform maintenance on the culvert to remove sediment.

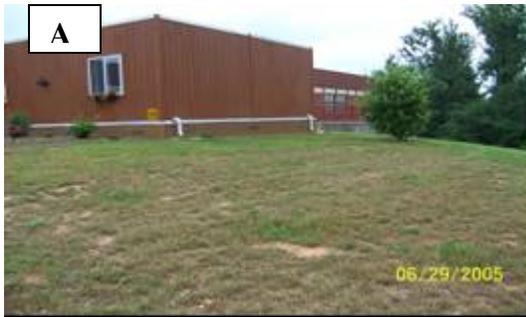
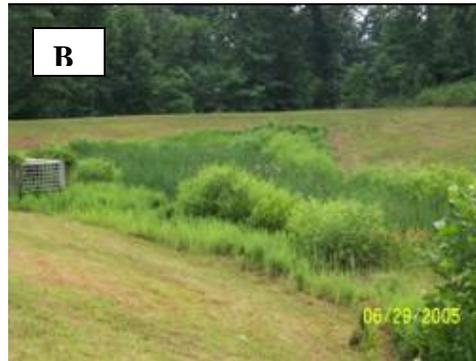
Description: These schools have a new, well-maintained stormwater management pond. The school campuses provide opportunities for several demonstration projects.

A) View of possible rain garden location. B) View of sunken area where second rain garden could go.

***Recommendation:** Install rain gardens as educational/demonstration tools in areas adjacent to an accessory building at the elementary school and/or within an open area near the entrance of the middle school.

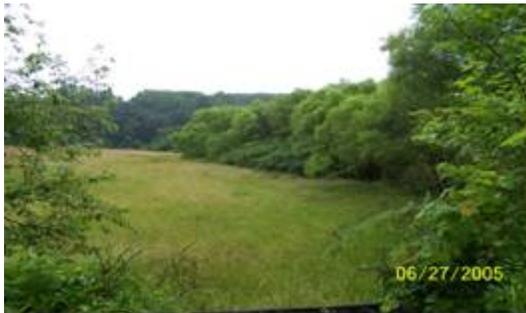
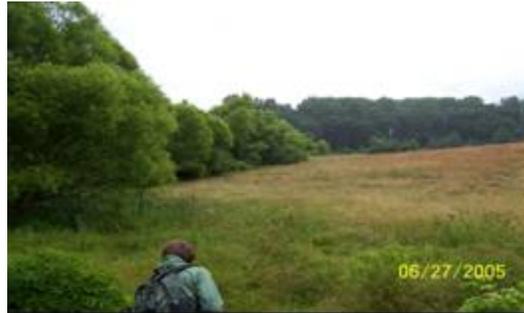
Description: The existing buffer is approximately 10' wide along the stream in this section.

Two views of buffer zones.

Recommendation: Should be approached as an opportunity to expand forested buffer.

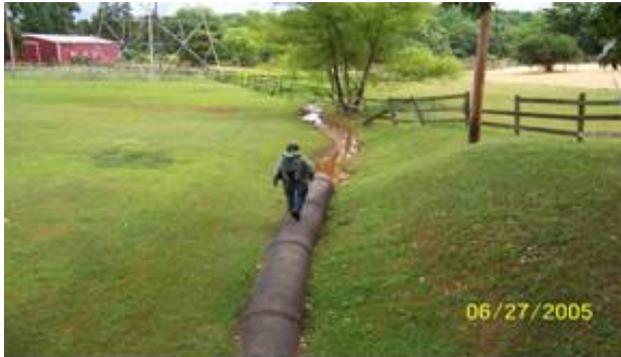
Description: There is no existing buffer of the stream in this section and the stream is piped until it crosses a power easement.

View of piped stream with no buffer zone.

Recommendation: Suggest a no-mow native vegetation area along stream. Investigate rationale for piping stream to see if potential to remove and restore channel.

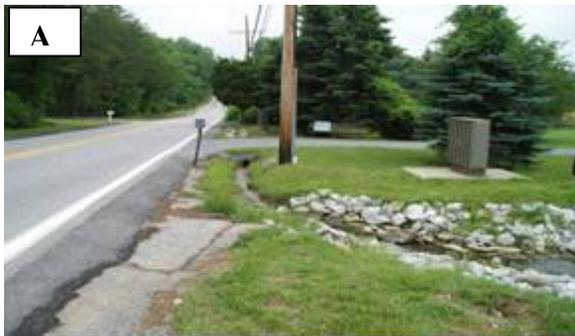
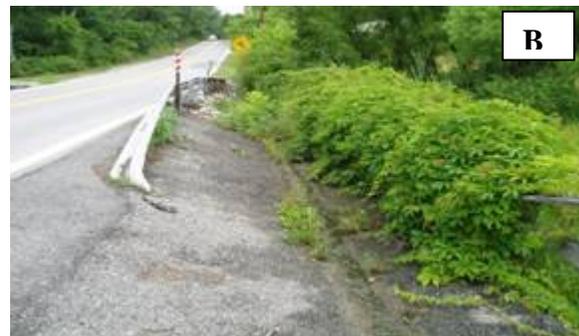
Description: Run-off flows leave a grass swale and new stormwater management facility at Grace Episcopal Church, and return to an asphalt channel along side Landing Road.

A) View of water leaving church. B) View of water running to the stream.

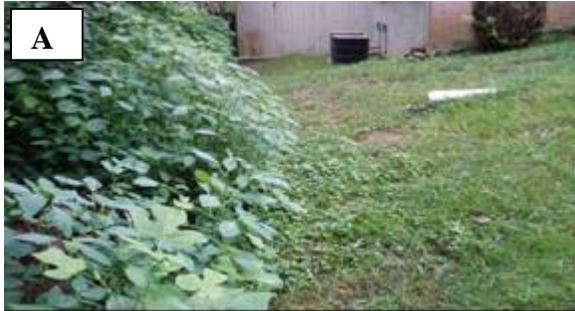
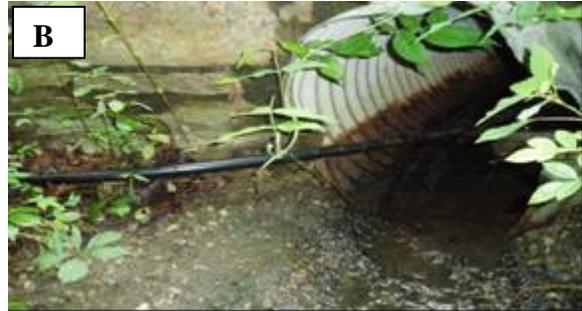
Description: SHA property south of I-95 along a tributary presents an opportunity to provide channel protection control. The downstream channel (north of I-95) is experiencing significant erosion.

A) View of buffer area. B) View of culvert under Lawyers Hill Rd.

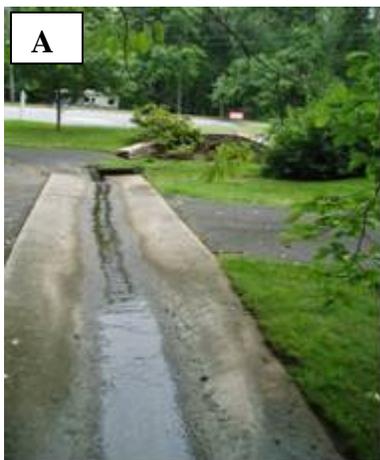
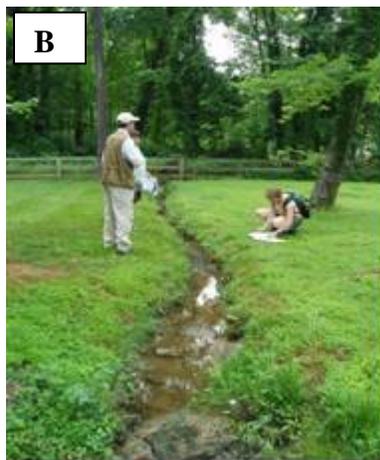
Description: Private home where the stream crosses the first driveway in a concrete channel (vehicles drive through channel). The stream is piped under the second driveway and part of the yard. The stream then enters a channel/ditch that is mowed to the bank.

A) View of stream crossing the driveway. B) View of stream in mowed ditch/channel.

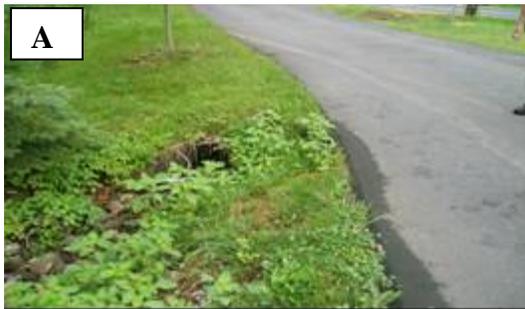
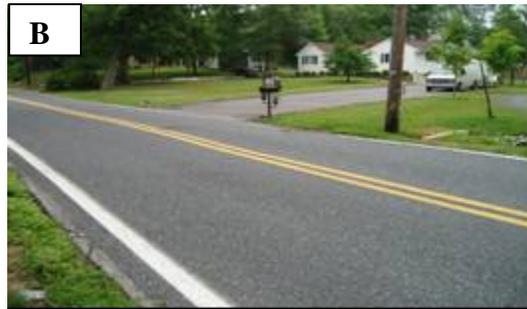
Description: The tributary parallels a driveway off Lawyers Hill Rd. and there is less than 5’ buffer on either side.

A) View of Tributary running underneath a driveway. B) View of Lawyers Hill Rd.

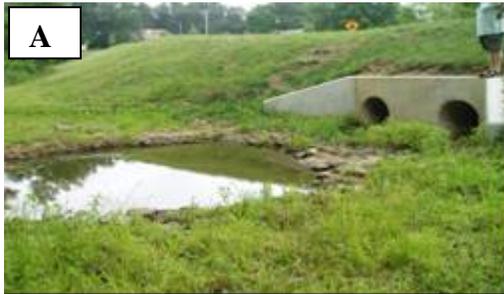
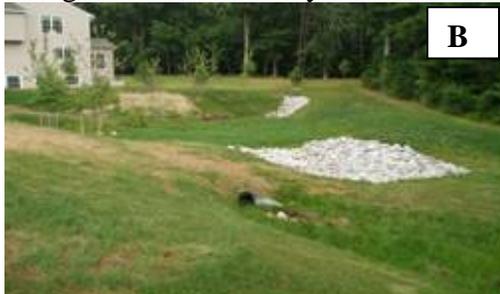
Description: The areas downstream of the outlet from this stormwater management facility are being mowed, and likely fertilized.

A) View of the culvert. B) View of outlet from SWM facility.

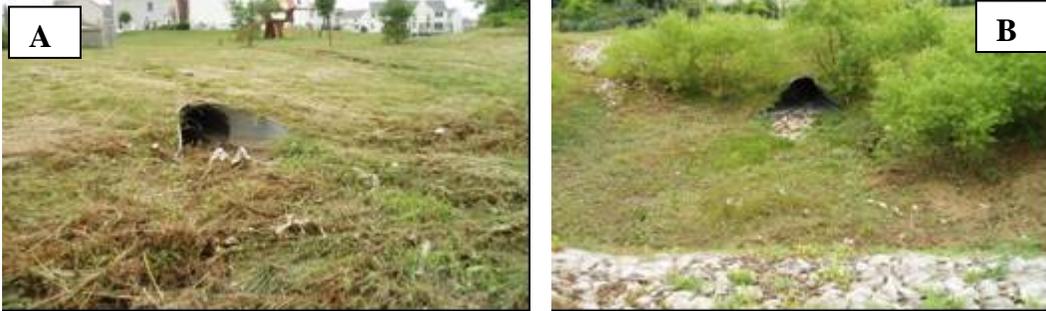
Description: This is a new subdivision that appears to have dry ponds (possibly infiltration basins). The adjacent homeowner complains of flooding.

A) View of outfall to dry pond 1. B) View of outfall to dry pond 2.

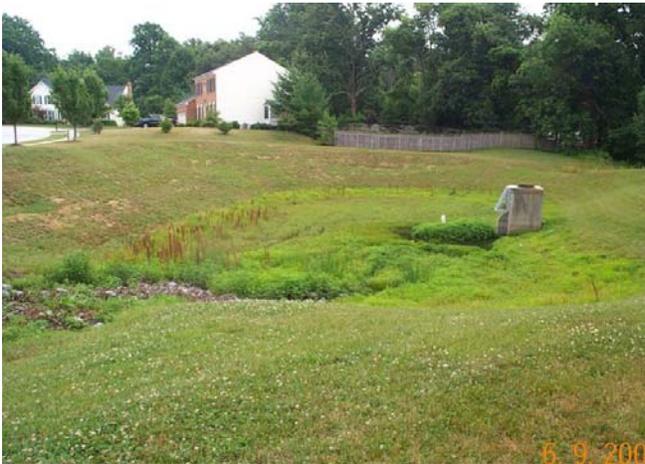
Description: This is an existing stormwater management facility that treats runoff from a residential area.

Picture of the facility
