Assessing the Rockburn Branch Subwatershed of the Lower Patapsco River for Restoration Opportunities

Prepared for:
Howard County, Maryland
Department of Public Works
Bureau of Environmental Services
NPDES Watershed Management Program

Prepared by:
JoAnna Lessard and Sam Stribling, Tt

January 23, 2006
Final Draft

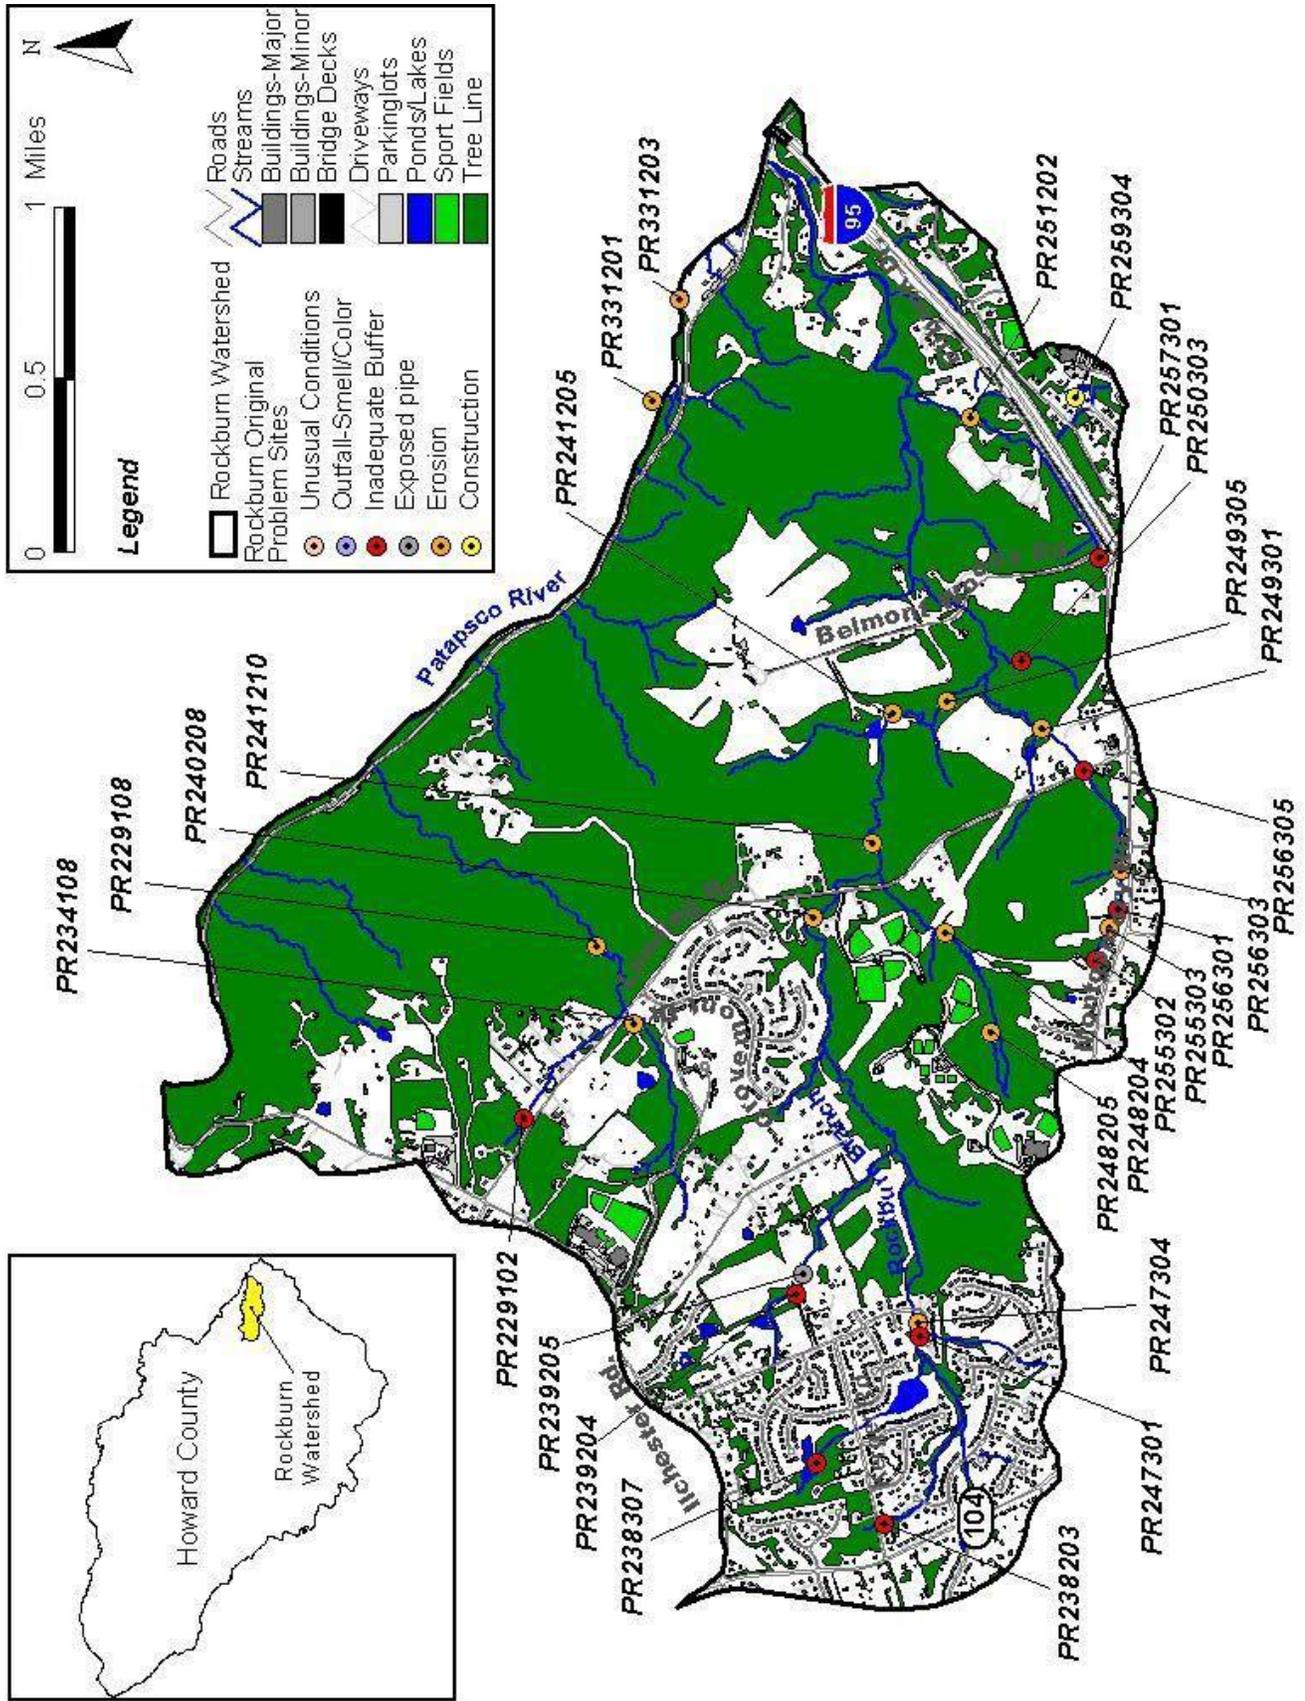
Figure 2. Rockburn Branch Subwatershed problem site locations and types from the SCA

The workgroup developed the criteria to prioritize problem sites, identified in the SCA surveys, for additional investigation. These criteria were intended to identify those problems that posed the most severe and immediate threats to water quality, and to maximize benefits for water quality and habitat. Criteria were chosen to place an emphasis on problems that could be addressed through the County Capital Budget. The first criteria, was to select sites with exposed pipe, pipe outfall, unusual condition, construction, erosion or inadequate buffer problem types. Further select only those pipe outfall sites with a discharge that have some associated coloration or odor. The second criteria, was to select for only moderate to very severe ranked problems within each type. Erosion sites that threaten infrastructure were included, however, even if they were given a low or minor severity ranking. A summary of identified problems from the Rockburn Branch subwatershed are presented in Table 4 and Figure 2.

Priority Problem Type	Number of Sites
Erosion	15
Inadequate buffer	10
Exposed Pipe	1
Construction Site	1
